Vidor CN435 **Battery Valve Radio Restoration** Mike M1DPB

Approach to Restoration - CN435 Circuit

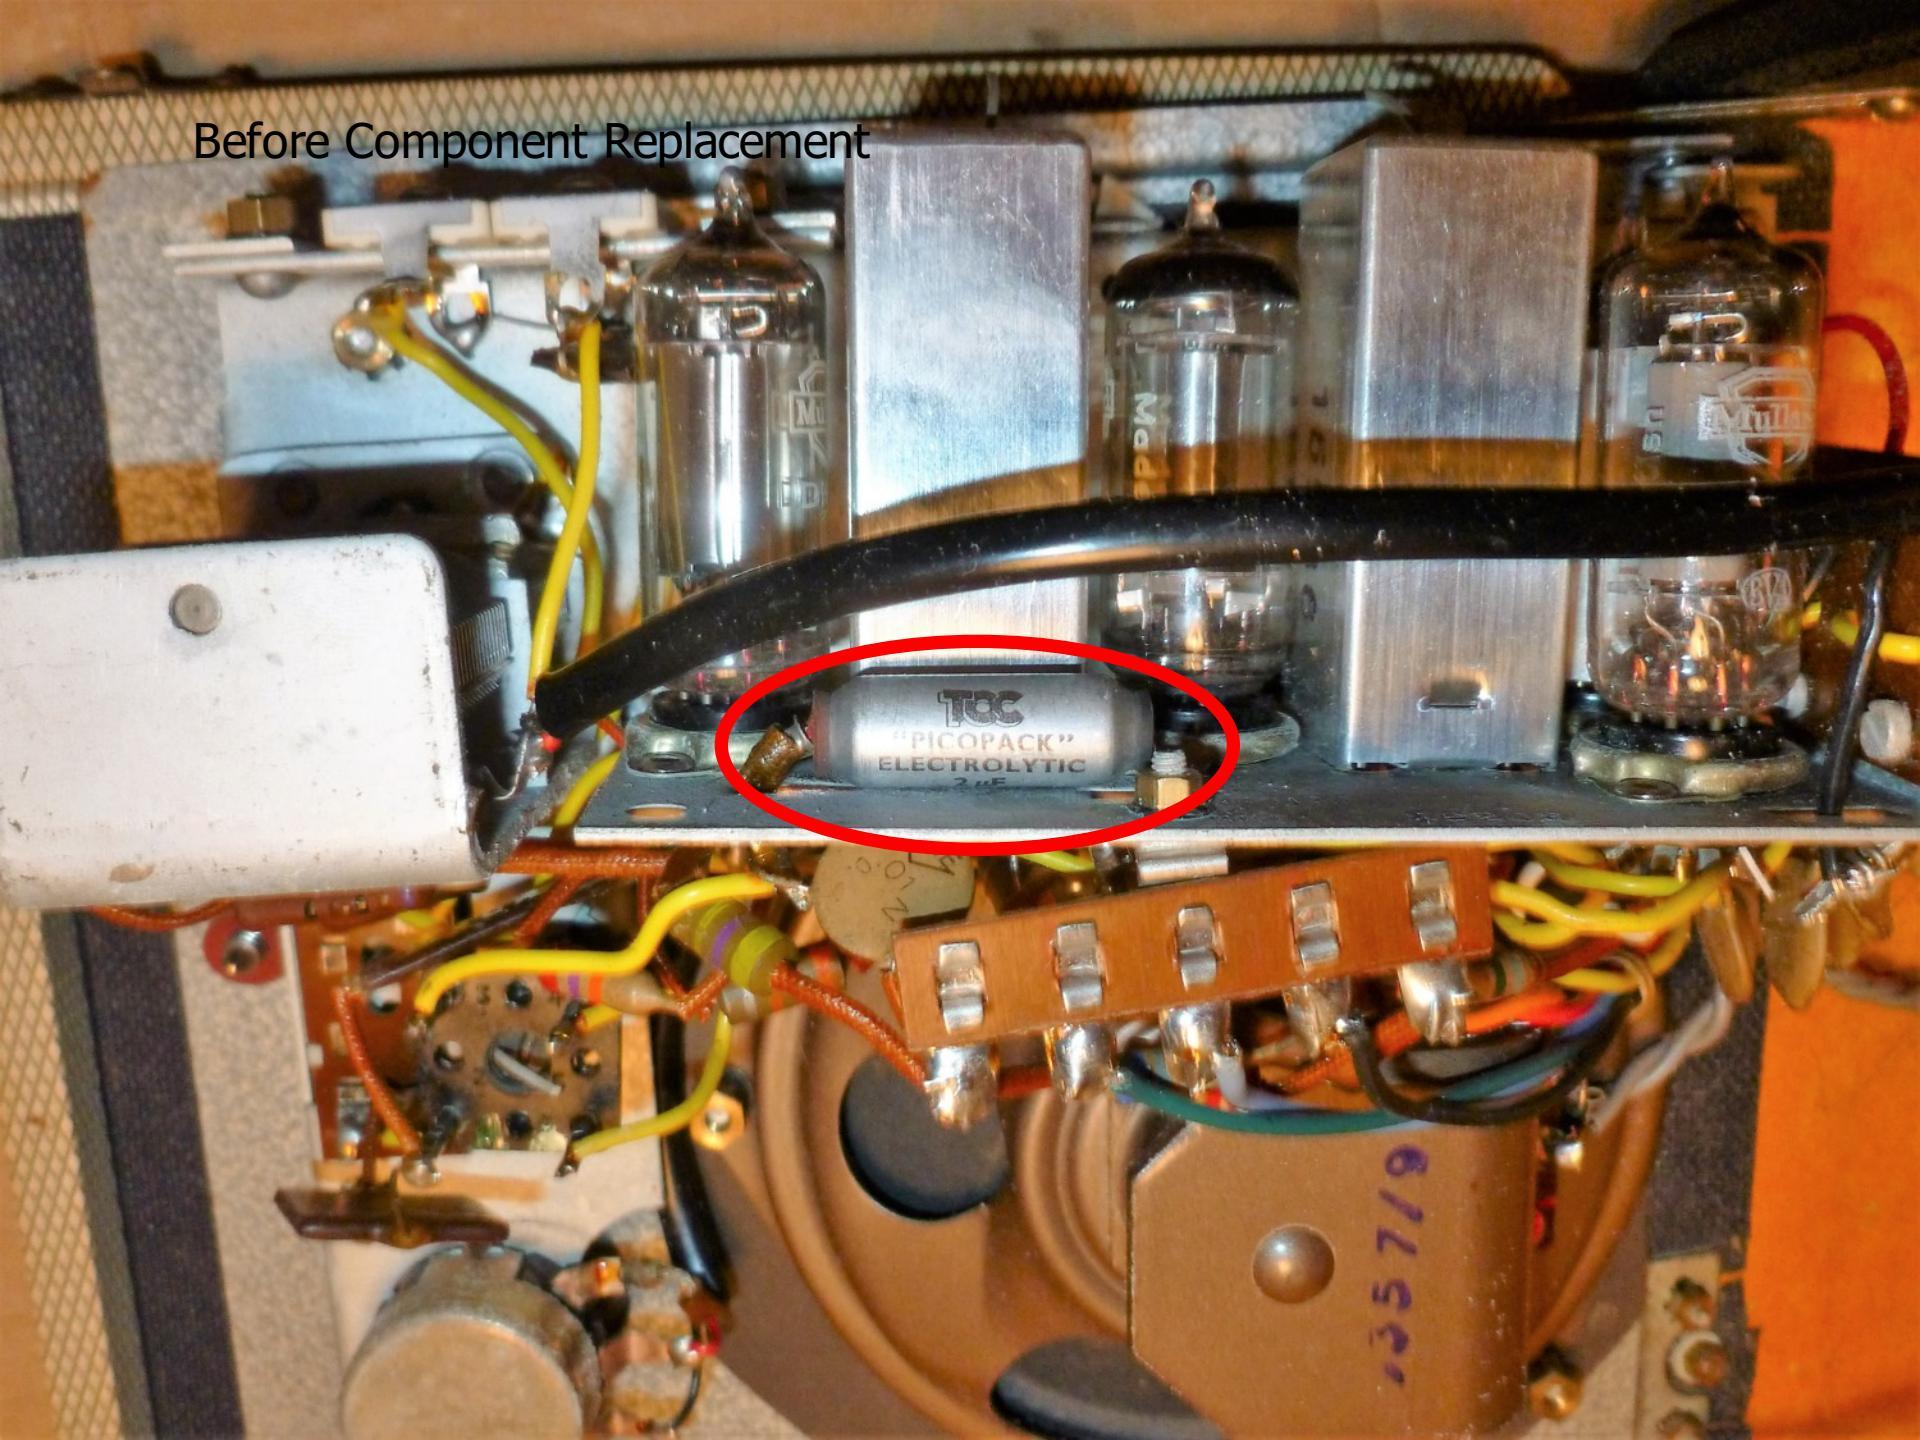
Approach to Restoration - Initial Checks and Repairs III The one electrolytic capacitor was replaced as a precaution to avoid small leakage currents wasting valuable HT. If this capacitor is retained, it will need to be reformed until the leakage current is within the manufacturers' specification

Before Component Replacement

Component Replacement

After

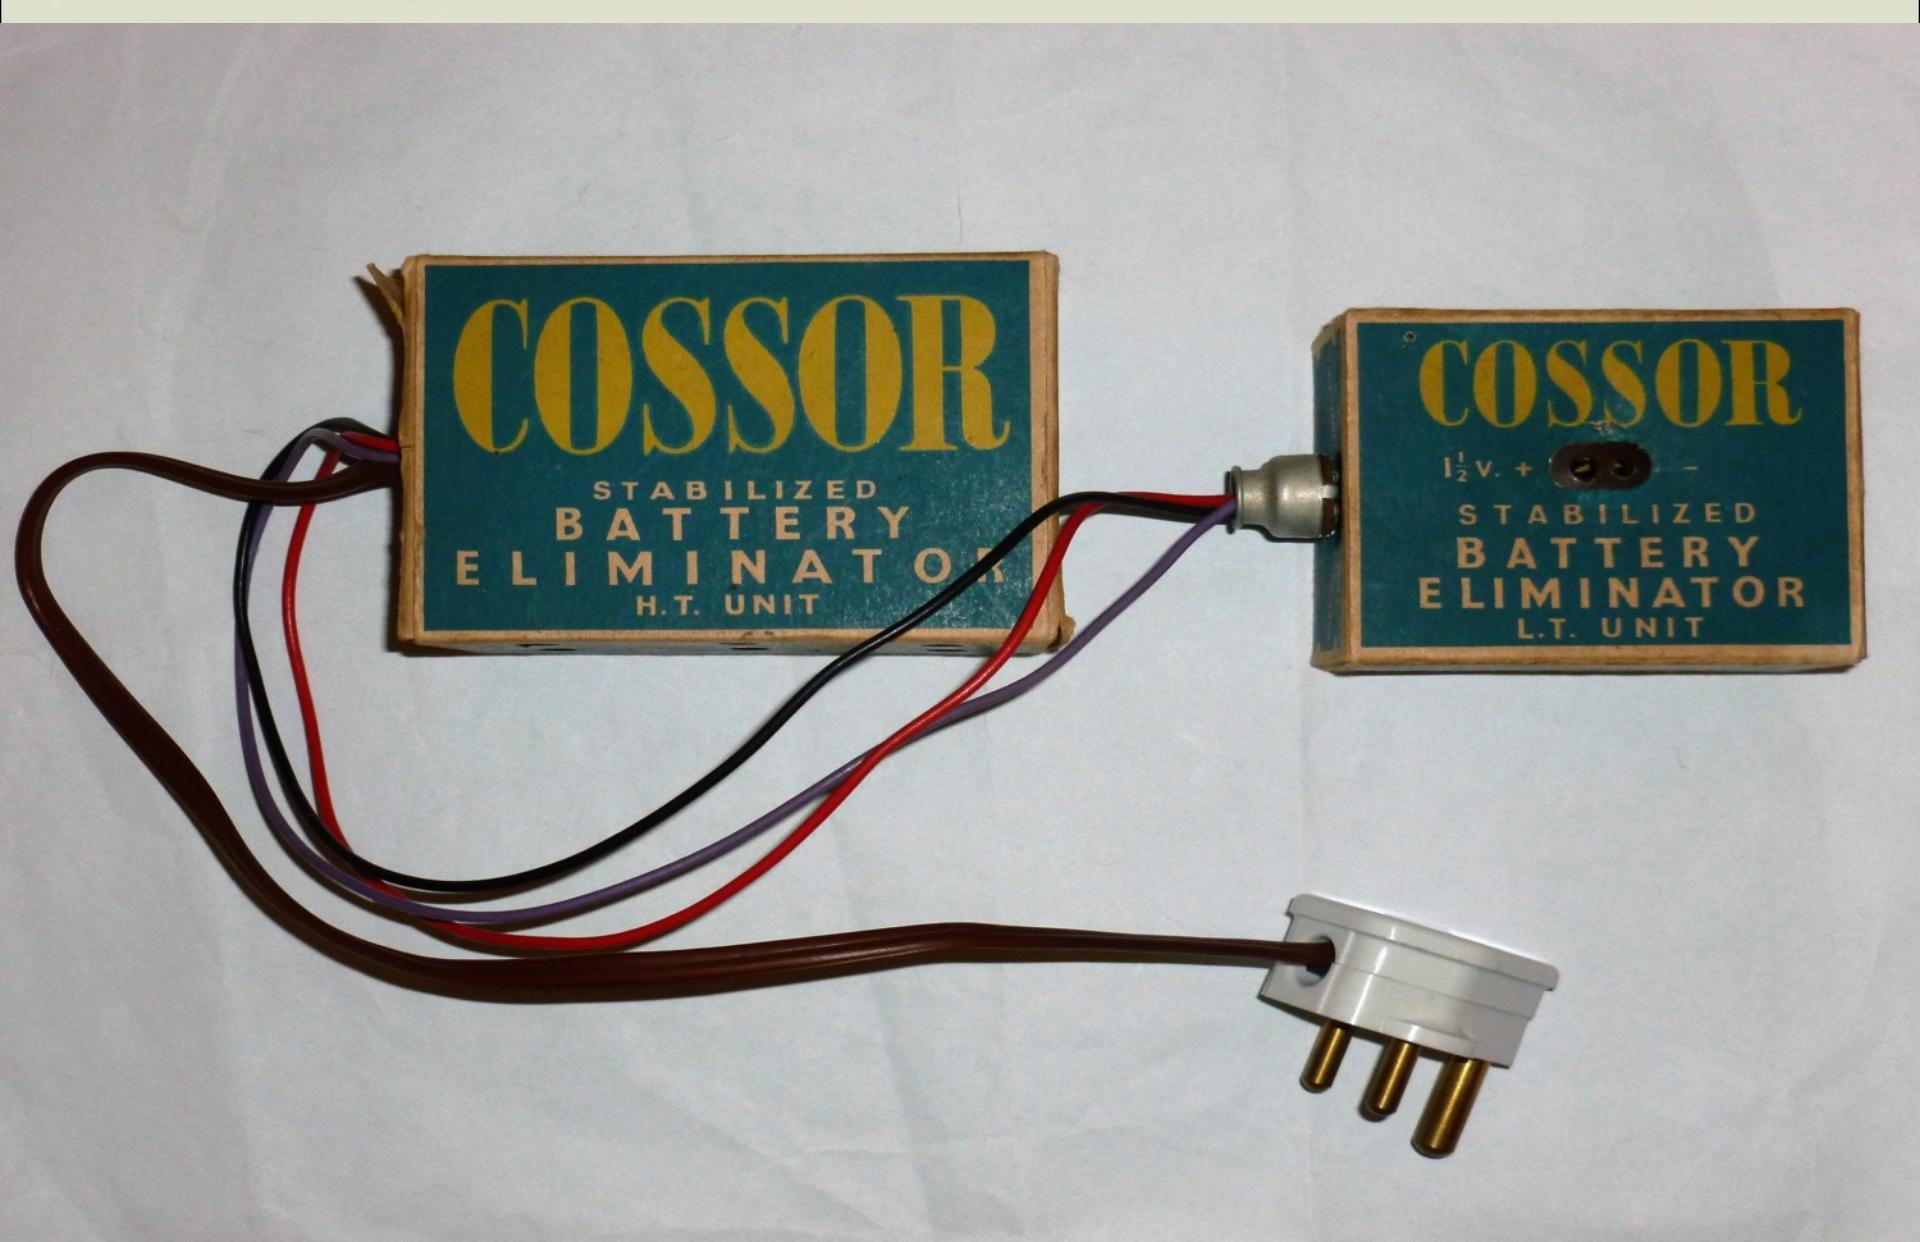
Vintage Mains Battery Eliminator

- Use mains eliminator power supply
 - Vintage Mains Eliminators will require restoration and safety checks before use!
- Use battery powered inverter Several proprietary and DIY designs available
- Use several PP3 batteries in series from same batch to fill replica battery box (Suitable Fuse!)
- A single NiMH (nickel–metal hydride) cell provides ideal LT voltage (Suitable Fuse!)

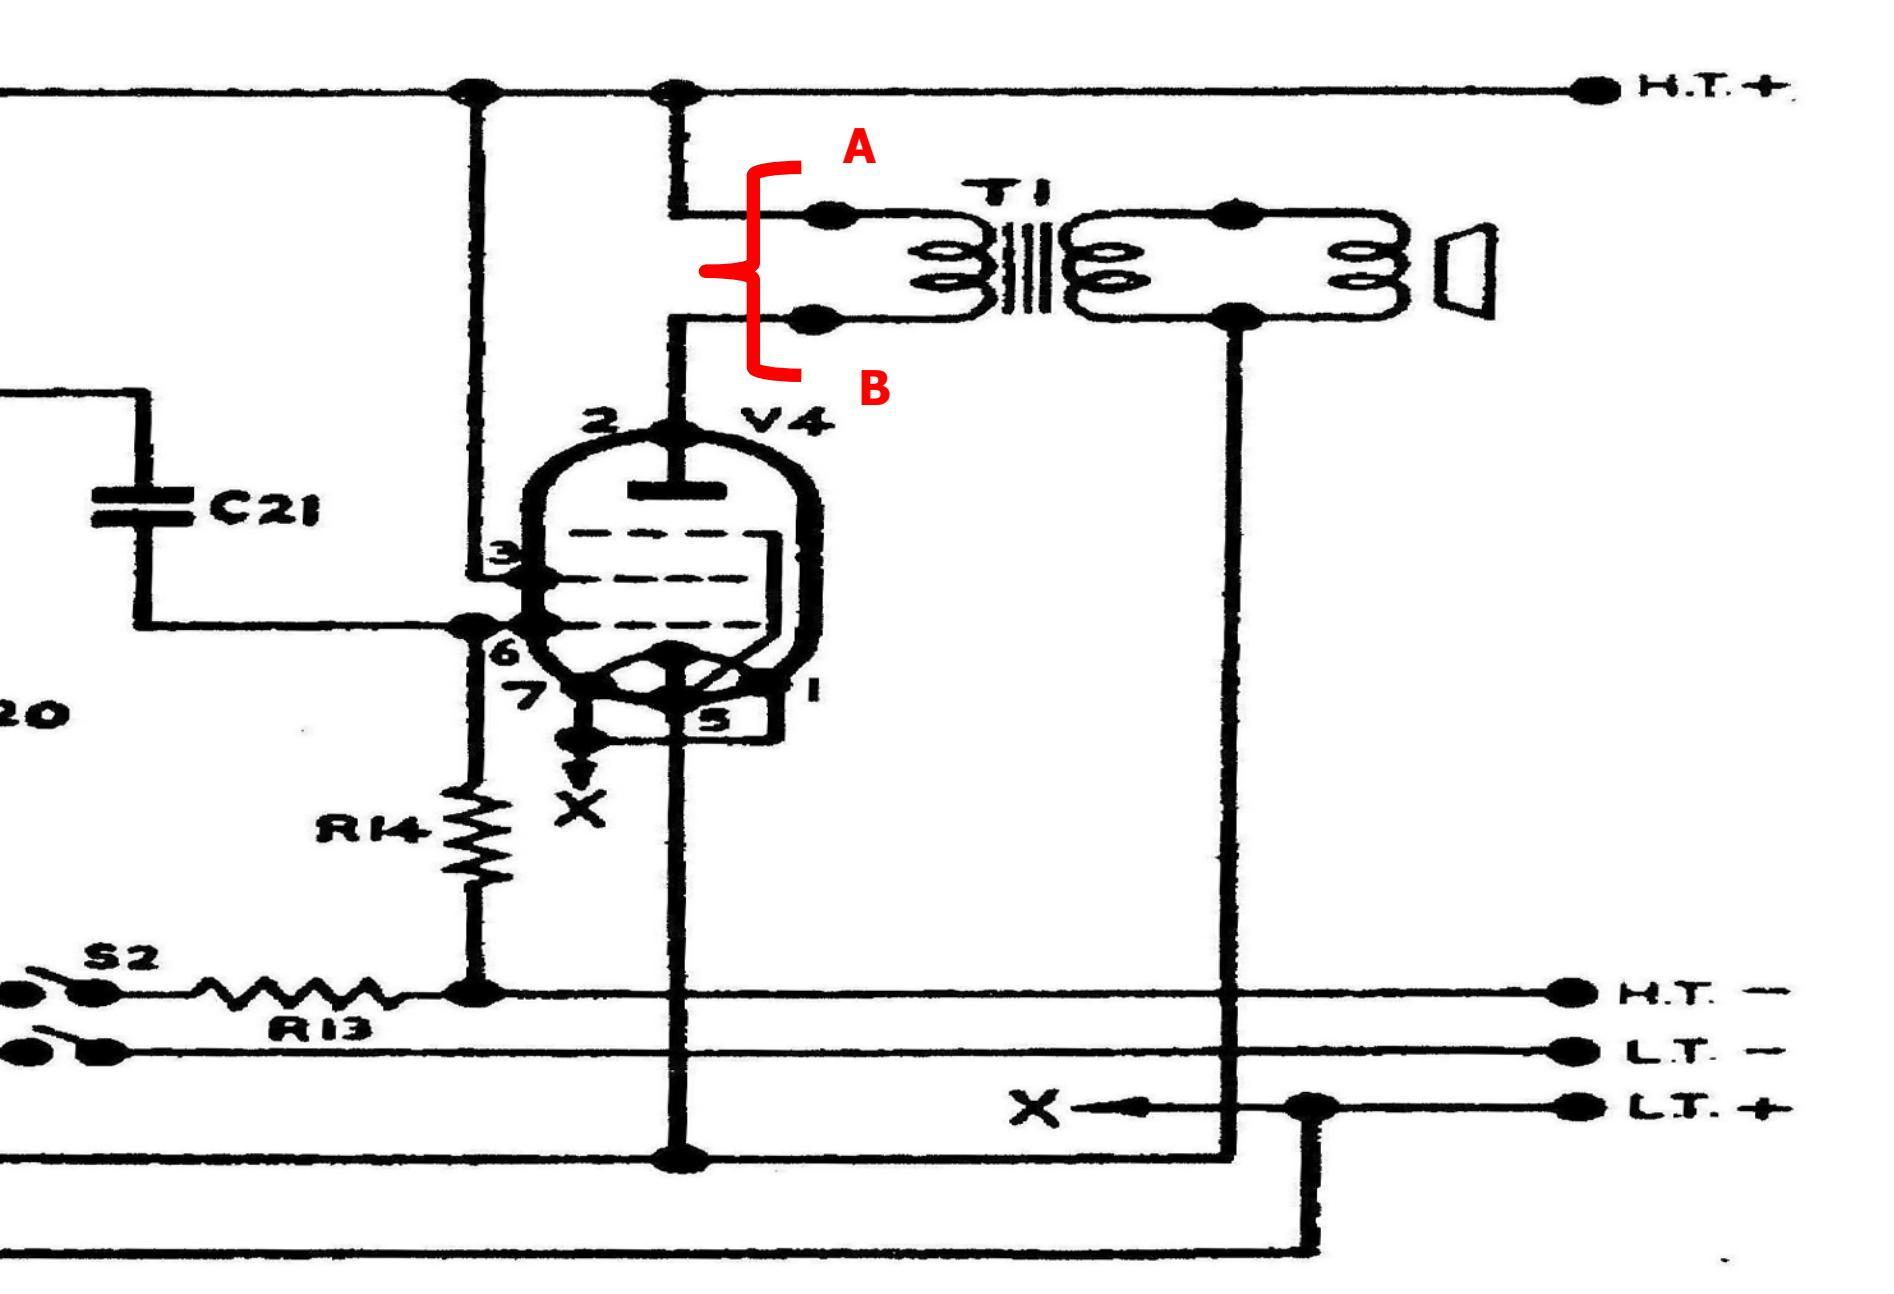
Faults Encountered

- Open Circuit Output Transformer
- Measured open circuit at points "a" and "b" below
- Very small transformer with fine windings
 After 60 years prone to green spot
 - corrosion
- Replacement transformer was salvaged from a scrap set

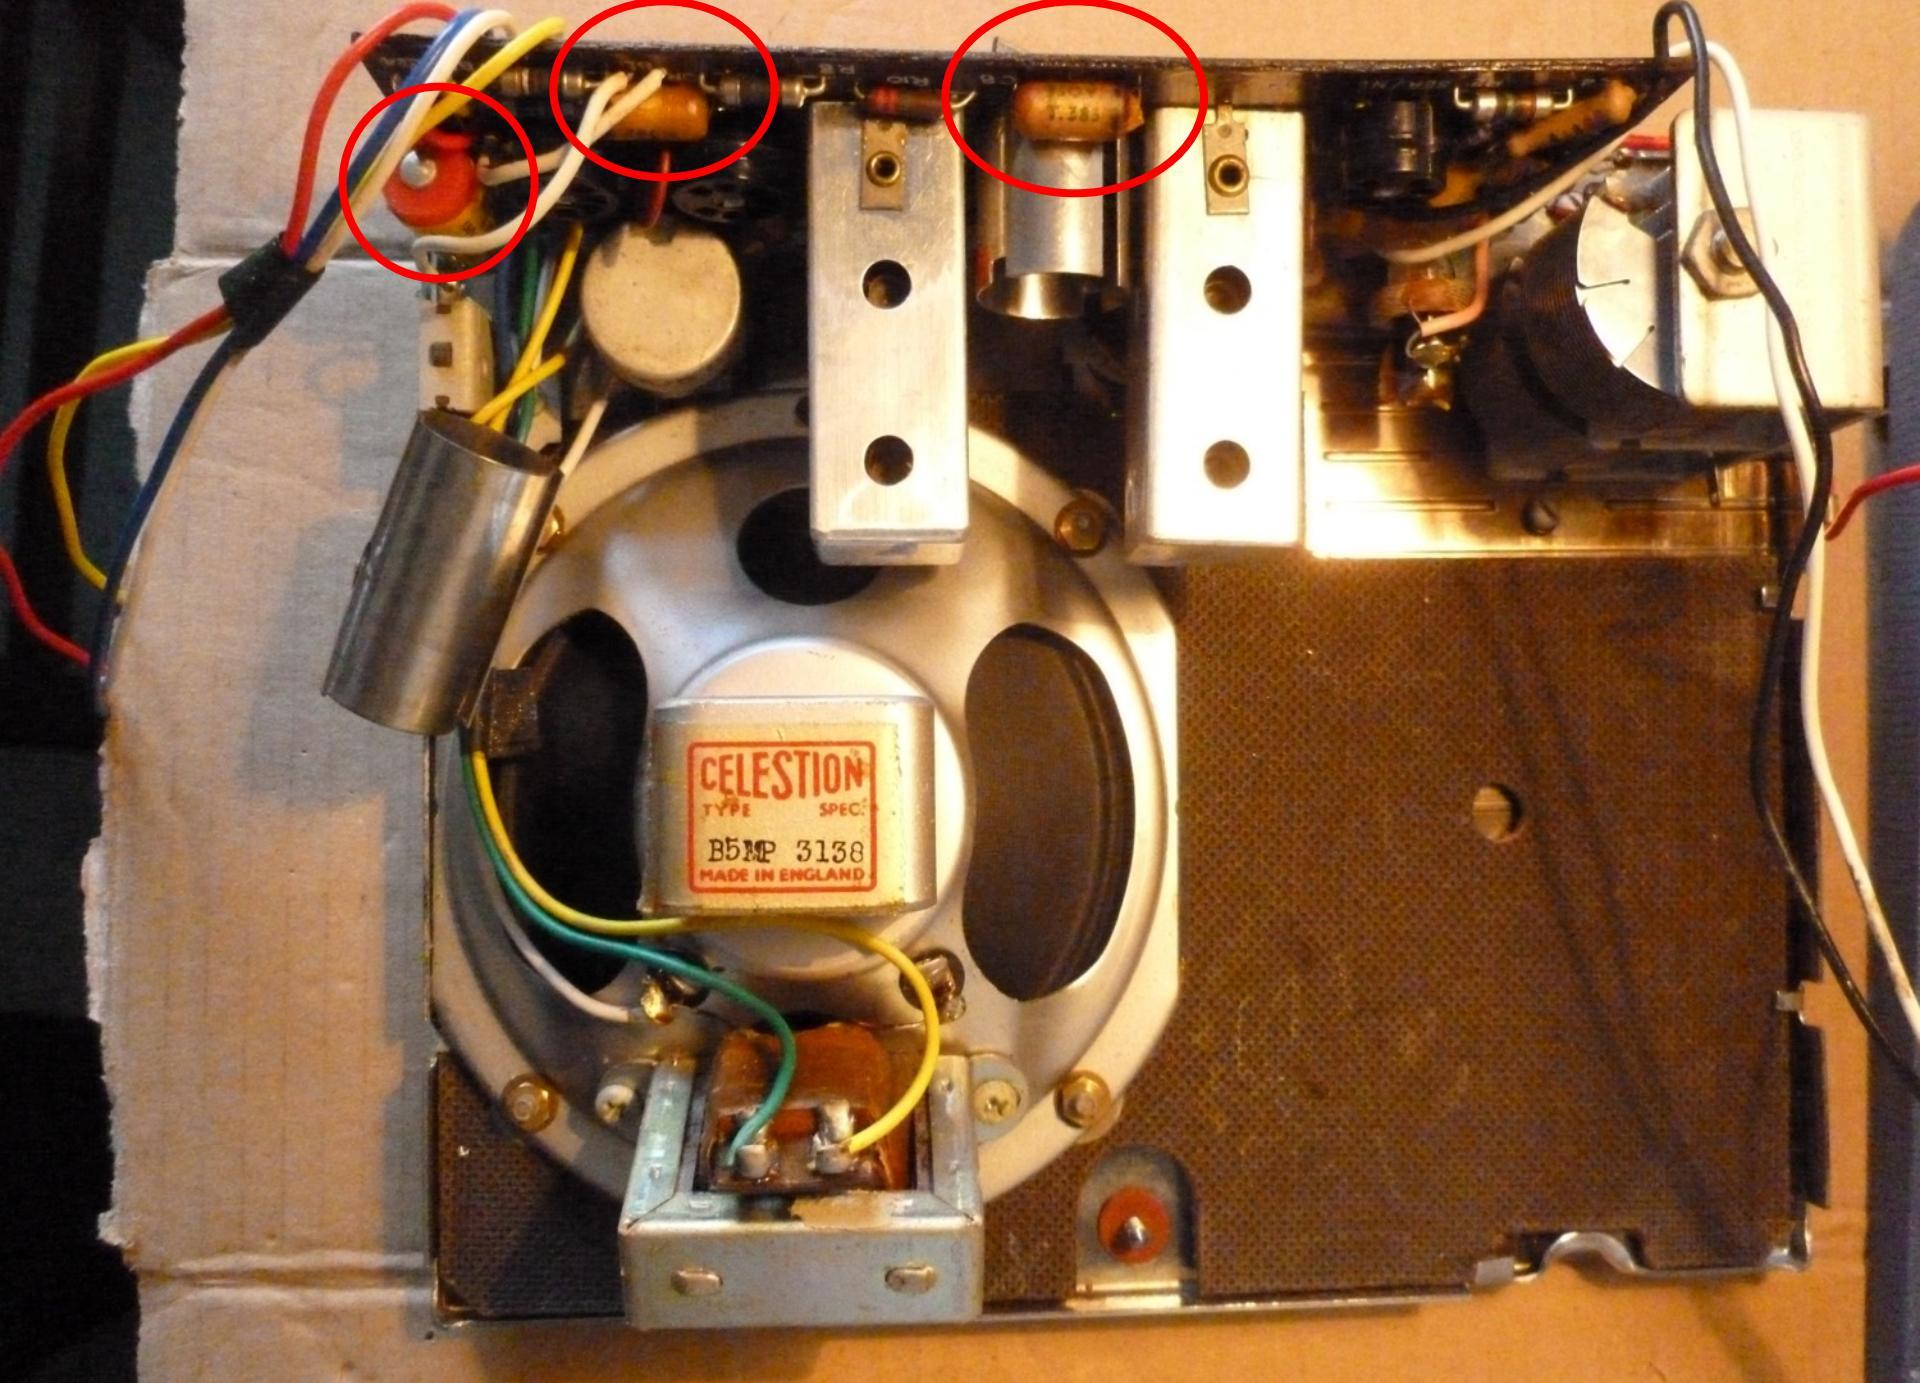
Another Example – PYE P114BQ Before Component Replacement

Another Example – PYE P114BQ After Component Replacement
